**Wood Drive Coastal Wetland
Invasive *Phragmites australis* Control and Assessment
Summary Report
2014 - 2016**

Prepared by:
Janice M. Gilbert, Ph.D.
Wetland Ecologist

Prepared for:
Nancy Vidler, Chair
Lambton Shores Phragmites Community Group

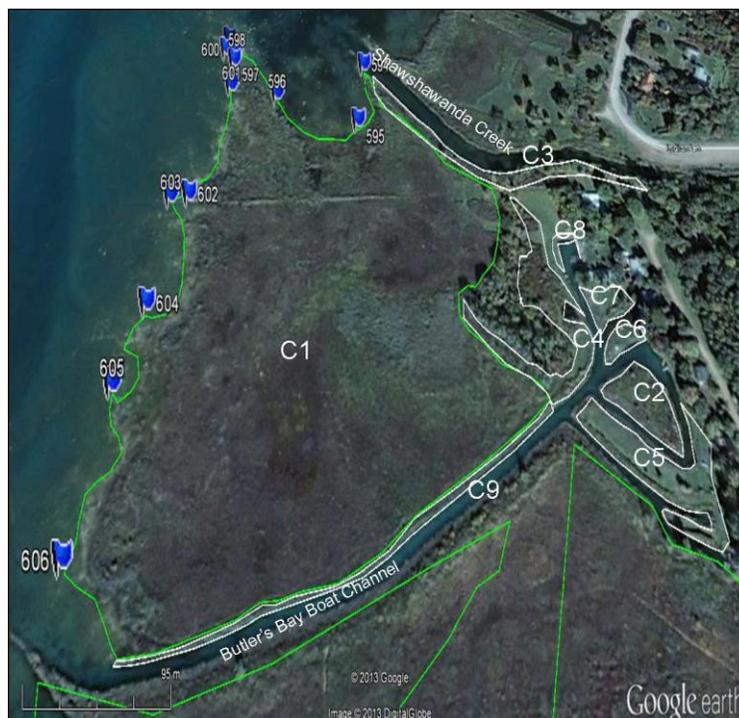
Figure 3. Satellite image showing areas requiring Phragmites control in Block 1.

The section outlined in green (C1) encompasses high density Phragmites which could be controlled using track vehicles or similar equipment; the areas demarcated by white lines (C2-C8) could be controlled using backpack spray units; cells along the boat channel (C9) and on the small island (C2) require boat access.

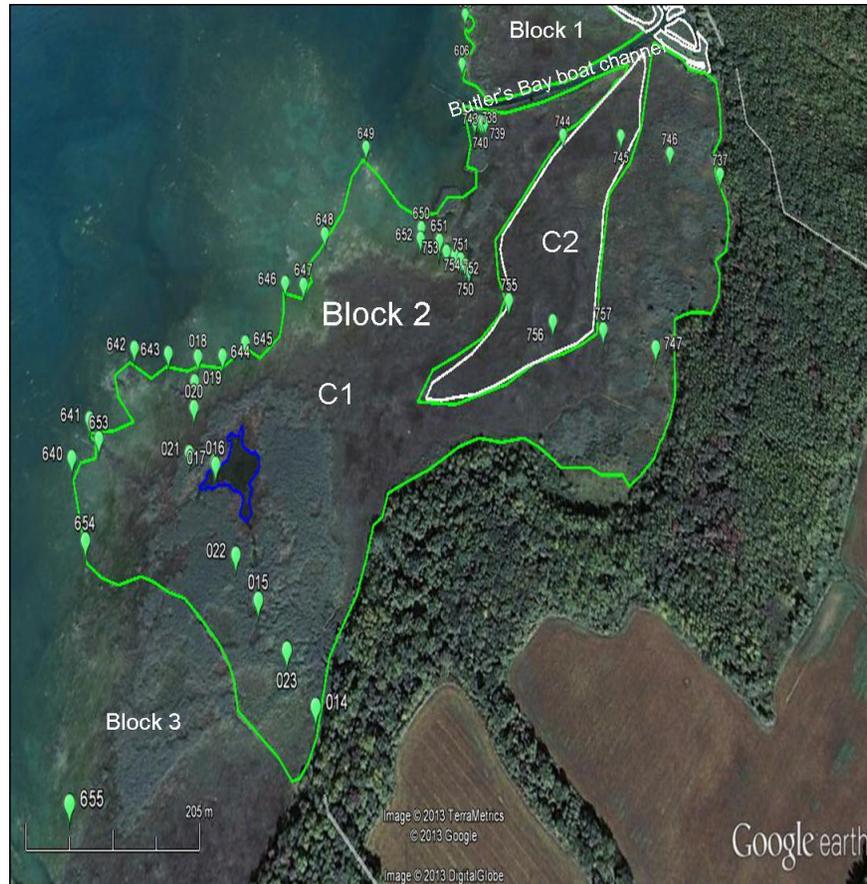
Figure 4. Satellite image showing areas requiring Phragmites control in Block 2.

The section outlined in green (C1) has dense Phragmites, the area demarcated by a white line (C2) has sparse Phragmites, and the area outlined in blue is a wet depression.

Block 2 is bordered by the Butler's Bay boat channel in the north and a trail running from the end of Fuller Road out to the shoreline in the south (Figure 4). This block encompasses ~39 ha (~97 ac) of which ~85% had dense Phragmites (C1) and ~6 ha (~14.7 ac) had sparse Phragmites (C2) in 2012/13.

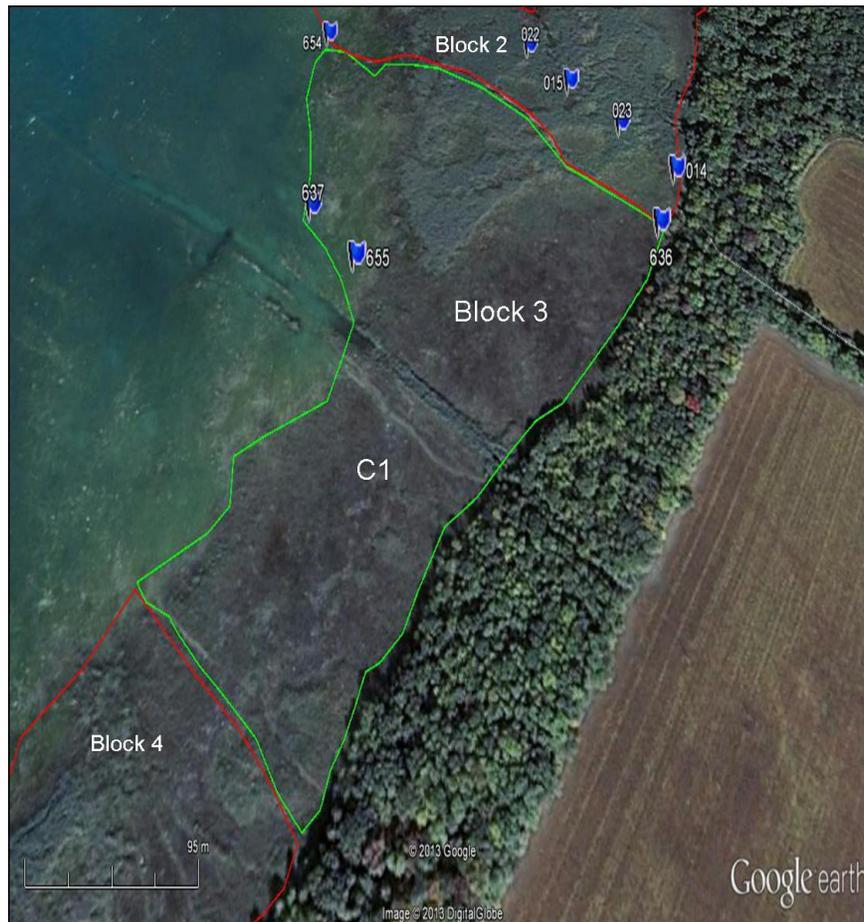
Figure 5. Satellite image showing areas requiring Phragmites control in Block 3.

The section outlined in green (C1) has dense Phragmites. Block 4 encompasses the Lambton United Church Centre property.

Block 3 covers the wetland portion located between the southern boundary of Block 2 southward to the property boundary shared with the Lambton United Church Centre (Figure 5). Phragmites control efforts on the United Church property have been ongoing since 2014. Block 3 covers ~9 ha (~23 ac) and at the time of the initial assessments in 2012/13 had medium to high Phragmites densities throughout.

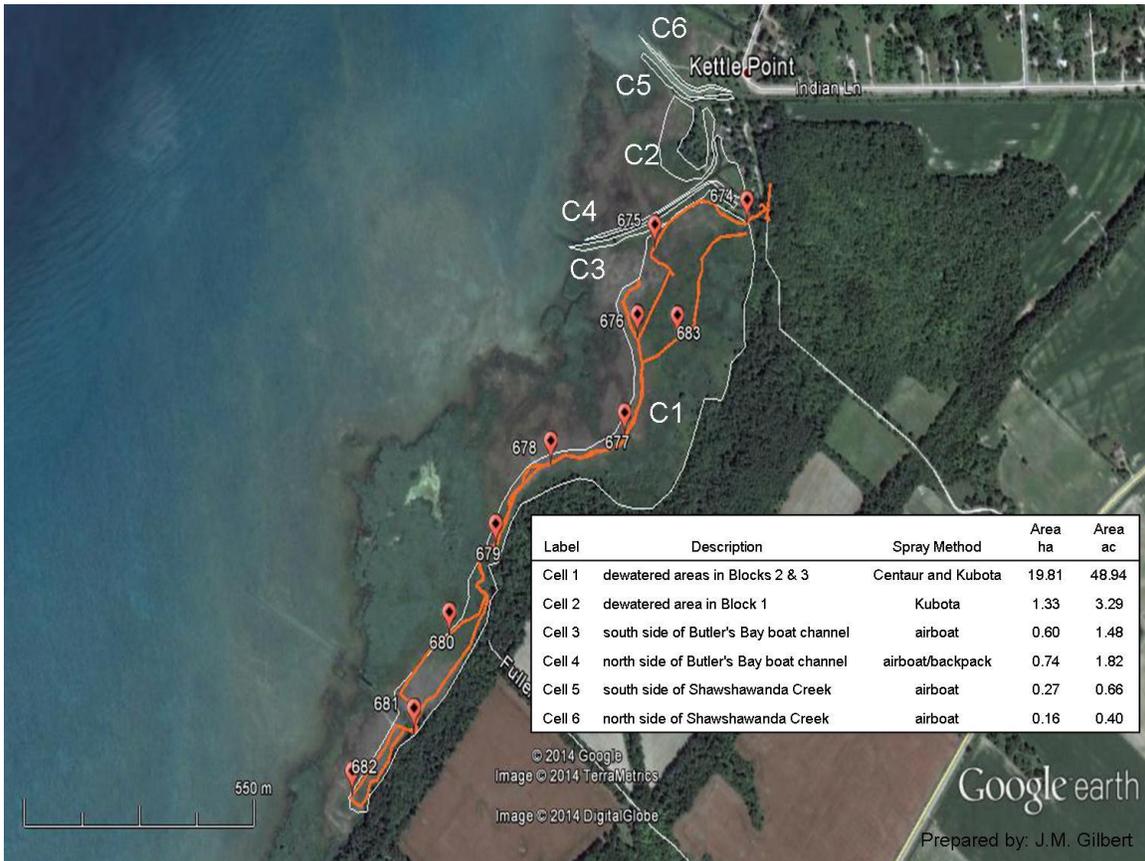
Figure 6. Areas where invasive Phragmites were treated with herbicide within the Wood Drive Coastal Wetland, fall 2014.

Phragmites located within dry sections in Blocks 1, 2 and 3 of the Wood Drive Coastal wetland were treated using an appropriate herbicide during the last week in September 2014 (Figure 6). This work was undertaken by a licensed contractor (Dover Agri-Serve) using a variety of equipment. An industrial track vehicle (Centaur) retrofitted with a spray deck, tank, pump and spray wand was used to treat high density cells. A light weight track vehicle (Kubota) equipped with a tank, pump and spray boom was used to treat intermediate density areas. An airboat equipped with tank, pump and spray wand was used to treat the dredge spoil ridges along the Shawshawanda Creek and Butler's Bay boat channel. And, a crew on foot used backpack spray units to target Phragmites in low density areas. In total ~23 ha (~50 ac) were treated.

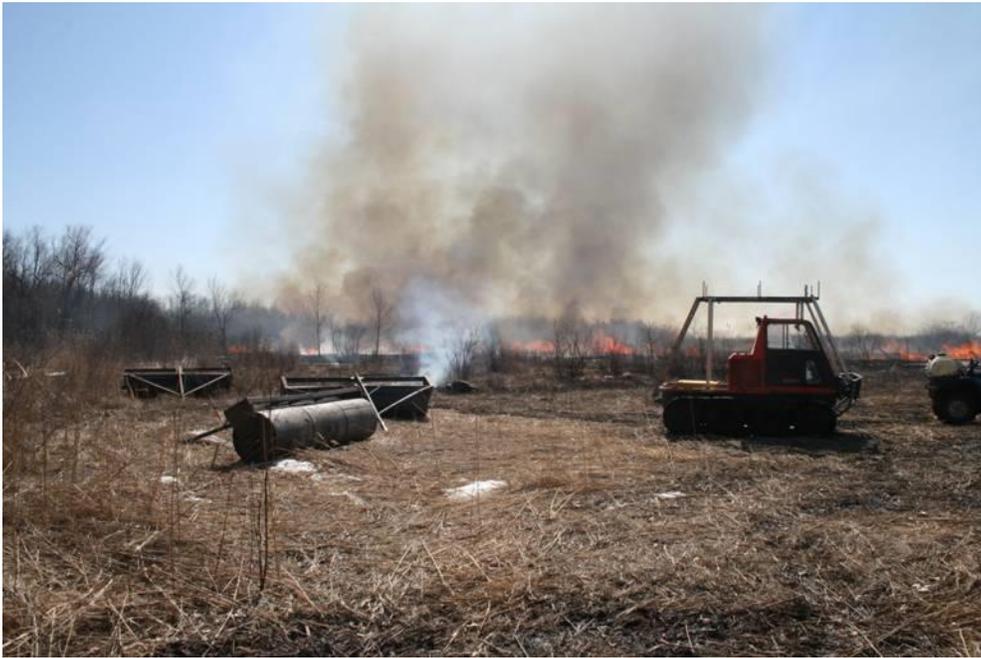
Figure 7. Track machine and rollers used to flatten standing dead Phragmites prior to a prescribed burn being undertaken, Wood Drive Coastal Wetland, March, 2015.

On March 24, 2015 standing dead Phragmites was rolled and then burned within the drier sections of Blocks 1 and 2. This work was undertaken to reduce the amount of biomass in the high density sections where Phragmites had been sprayed the previous fall in order to improve native plant recovery. Prior to burning, the Phragmites was flattened using industrial grade rollers pulled behind track machines (Figure 7). This allowed for a more controlled fire and complete incineration of the seed heads (Figures 8 and 9). High Lake Huron water levels significantly reduced the amount of acreage that could be rolled and burned but ~ 22 ha (55 ac) was able to be targeted. The work was undertaken by Dover Agri-Serve and Wildfire Specialists Inc.

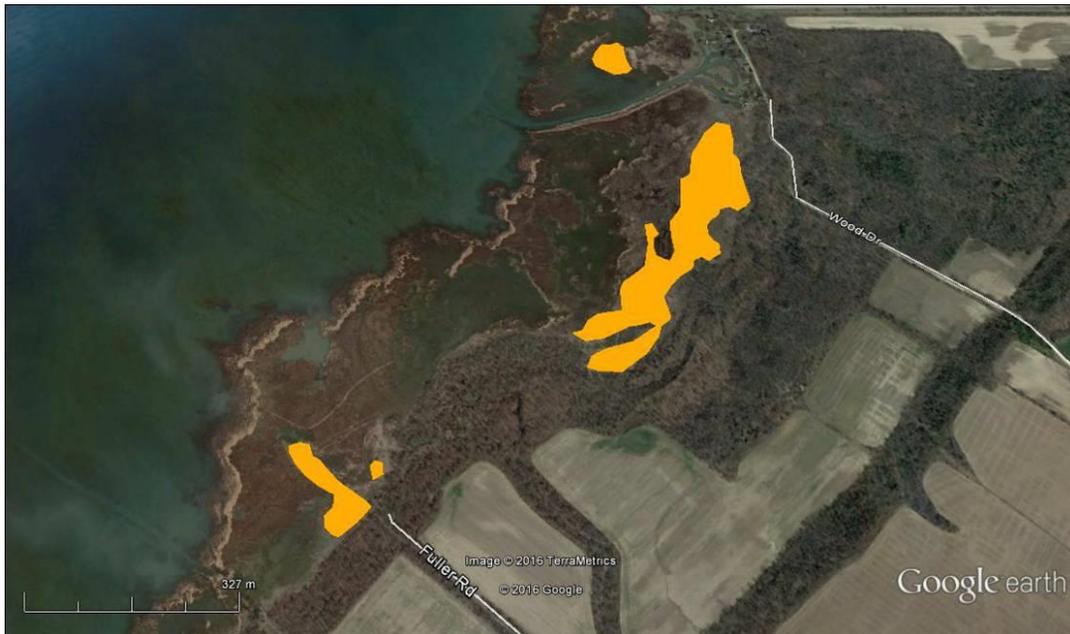
Figure 10. Dry areas within the Wood Drive Coastal Wetland where invasive Phragmites had been treated with herbicide, October 2015.

In early October (6th - 9th) 2015 dry sections within Blocks 1, 2 and 3 were treated with herbicide (Figure 10). Due to the high lake levels only ~6 ha (~15 ac) could be targeted. This work was undertaken by Dover Agri-Serve employees using an industrial grade track vehicle (Centaur) that had been retrofitted with a spray deck and equipped with commercial grade spray equipment.

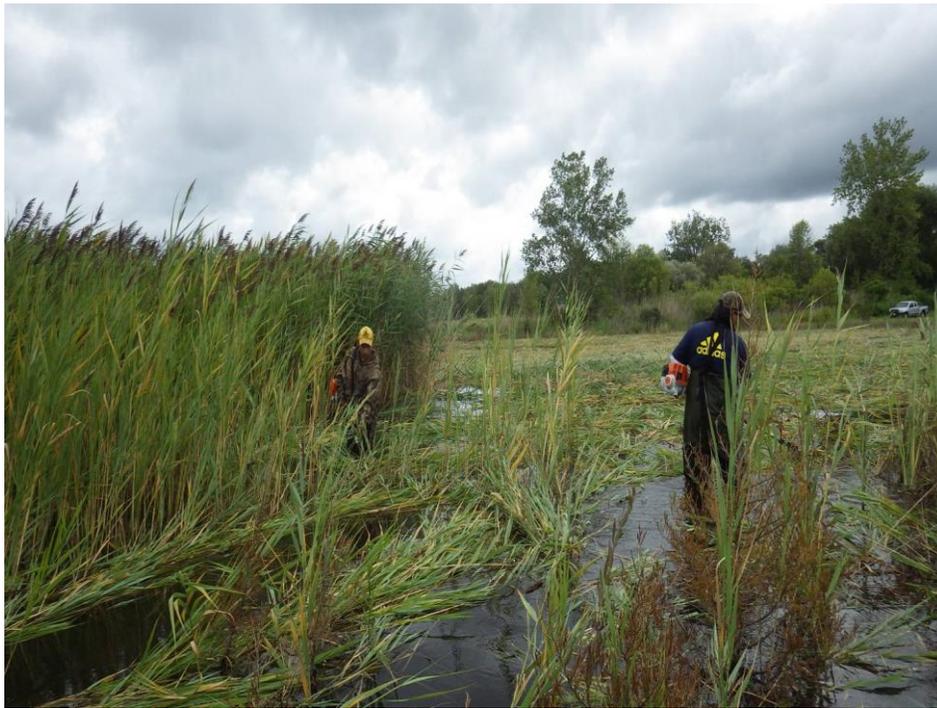
Figure 11. Cutting Phragmites in the Wood Drive Coastal Wetland, August 26, 2015.

The cutting occurred in Block 1 using gas powered brush cutters (Figure 11). Areas where Phragmites densities exceeded ~90% were too hard on the equipment and crew and therefore only areas with intermediate to low Phragmites densities were targeted (Figure 12). The work was slow and arduous as the cut material also had to be removed from the water to reduce sprouting and further spread. Approximately ~2 ha (5 ac) were able to be cleared by a three person crew working 10 days beginning August 22 and ending October 9, 2015. The following growing season Phragmites densities were found to have decreased by ~93% (Figure 13). More details about the cutting program can be found in the Wood Drive Coastal Wetland Invasive Phragmites Cutting Program 2015 - 2016 Summary Report (Gilbert, 2017).

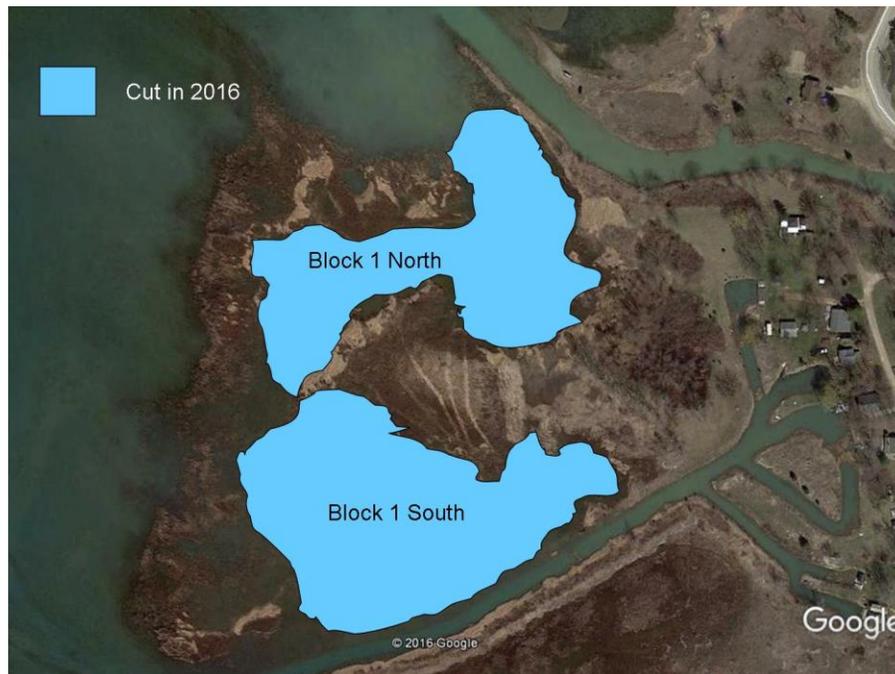
Figure 14. Phragmites areas cut within the Wood Drive Coastal Wetland in 2016.

Phragmites cutting continued within Block 1 on 11 days between June and November, 2016. A 5-8 person crew cut and removed Phragmites from a ~3.7 ha (9.2 ac) area. This included the same area cut the previous year to remove any remnant Phragmites that had survived the cutting in 2015 (Figure 14). The majority of these plants were located in shallower water.

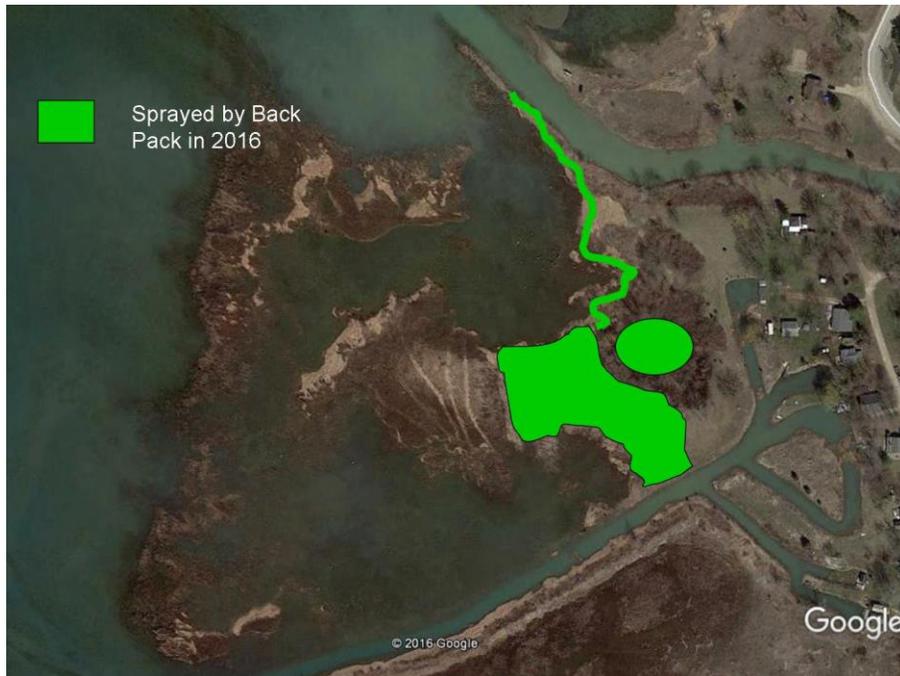
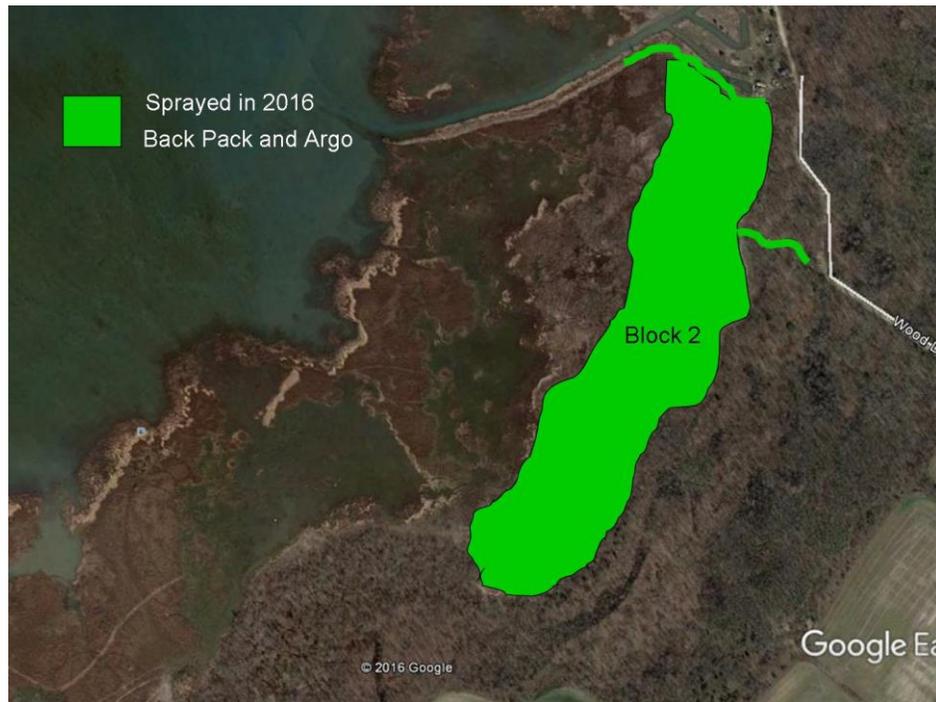
Herbicide application took place in dry sections of Blocks 1 and 2 on September 24 and 25 and October 4, 2016 (Figures 15 and 16). This work was undertaken by a 4 person crew working for Green Stream. The herbicide was applied using backpack spray units and a light weight, eight wheeled, ARGO equipped with spray tank, pump and hand wand.

Figure 15. Areas in Block 1 where Phragmites was treated with herbicide in 2016.

Figure 16. Areas in Block 2 where Phragmites was treated with herbicide in 2016.

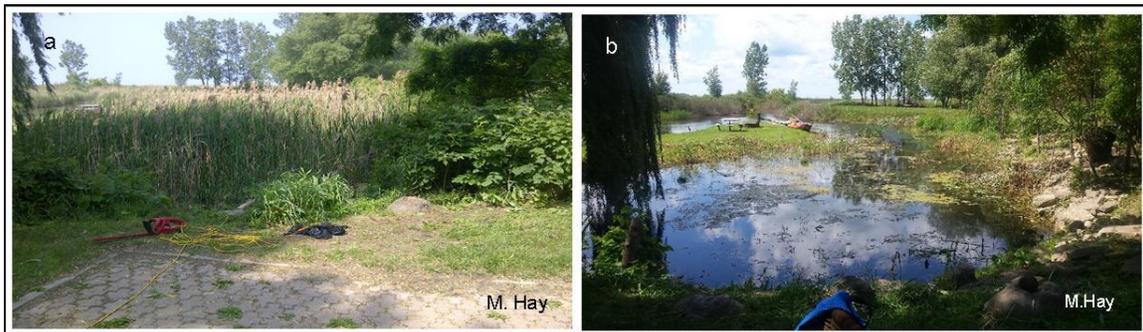
Figure 17. The Hay Cottage boat channel a) choked with invasive Phragmites, June 6, 2013 and, b) three years after manually cutting Phragmites, August 23, 2015.

Phragmites around the residential areas has been controlled over the years by some of the property owners. This has been mainly through manual cutting which needed to occur frequently to maintain low plant stature. As one cottager noted, the plants would grow back ~ 0.30 m in just one week after cutting (Hay, 2015; Appendix B). This same cottager started manually cutting the Phragmites in her boat channel in the summer of 2013. At that time the Phragmites was so thick and tall that she could not see the water and her view out toward the lake was severely restricted (Figure 17). With the help of friends, and after significant effort, they had managed to cut and remove all but a few of the plants by late summer 2015. Plants growing on dry ground around the perimeter of the boat channels and on the islands were treated by the backpack crew in 2015.

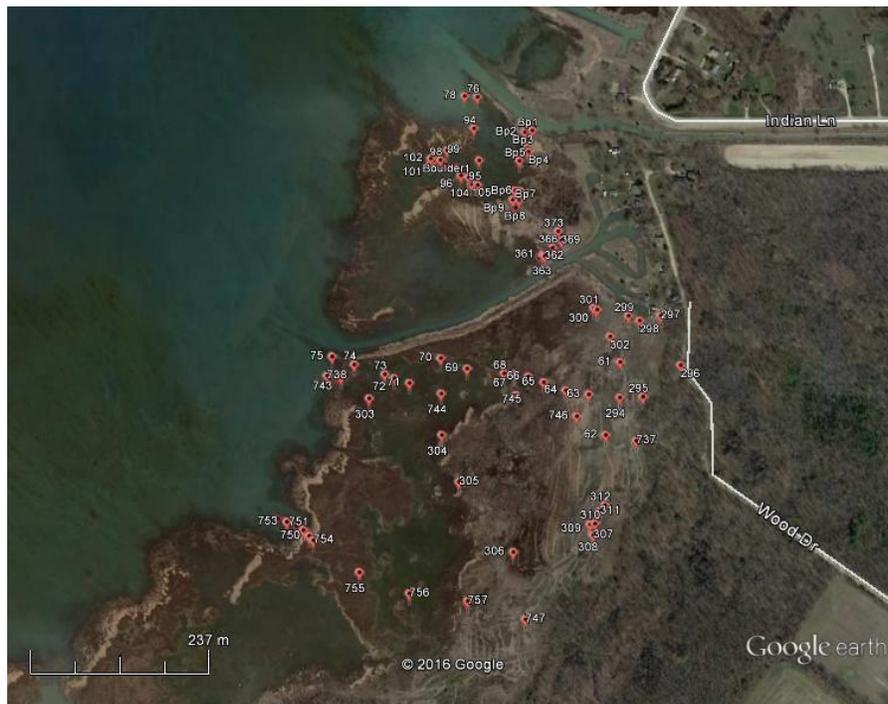
Figure 18. Locations of areas assessed within Blocks 1 and 2 of the Wood Drive Coastal, 2016.

The majority of the assessment plots were located in Blocks 1 and 2 within a narrow, drier zone in the meadow marsh community between the tree line and the water's edge. Phragmites within this area had been treated with herbicide in 2014 and 2015 resulting in significantly reduced densities. The assessment occurred during the peak biomass period prior to herbicide control activities being undertaken in 2016. Additional plots were also assessed across a water depth gradient, in areas that had undergone treatment in either 2014 or 2015 but were wet in 2016 and in areas that have not undergone control activities (Figure 18). All plots will be re-assessed in 2017. Phragmites control efficacy and native plant response to herbicide treatments will be used to inform control activities to be undertaken in 2017. Data collected in areas that could not be treated in 2016 will be used to track Phragmites expansion and vegetation response relative to site specific conditions such as water levels.

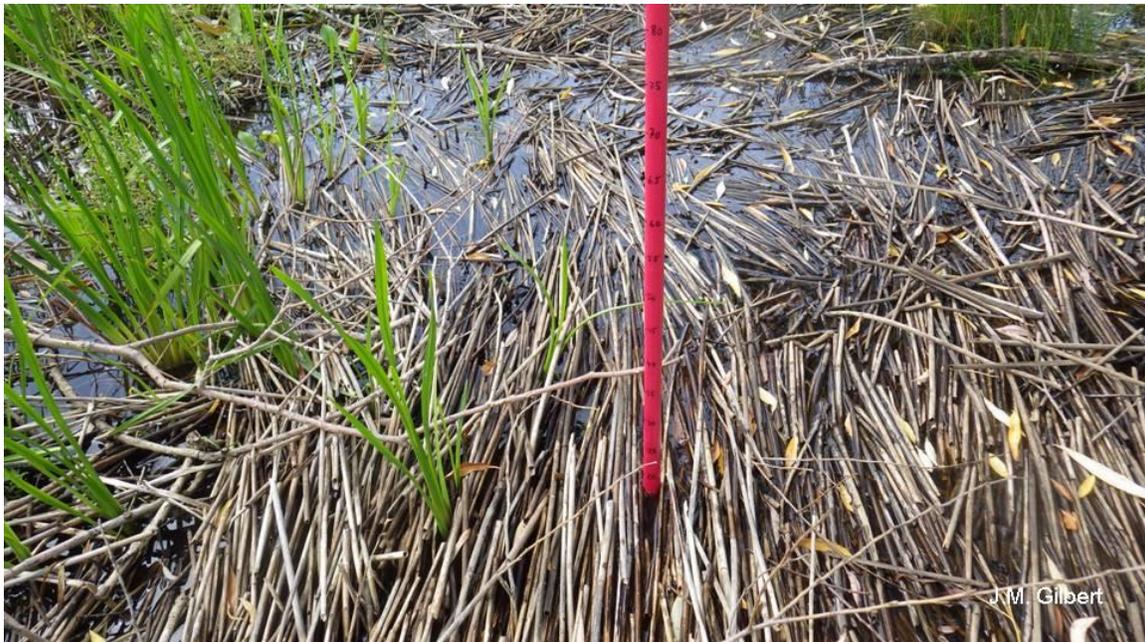
Figure 21. Thick layer of dead, prostrate Phragmites stalks prevent native plant growth within the meadow marsh community, Wood Drive Coastal Wetland, August 2016.

There were 84 plant species observed within the assessed plots in the meadow marsh community (Appendix C). Of these, 74 were native with a combined relative coverage of $\sim 42\%$. The 10 invasive plant species had a combined relative coverage of 25% (Table 1). About one third ($\sim 33\%$) of the area was not vegetated and these open areas mainly occurred where there was a thick layer of dead *Phragmites* (Figures 21 and 22). The dead *Phragmites* was a remnant of the control efforts undertaken in 2014/15 whereby

Phragmites treated with herbicide had been rolled but could not be burned due to wet site conditions.

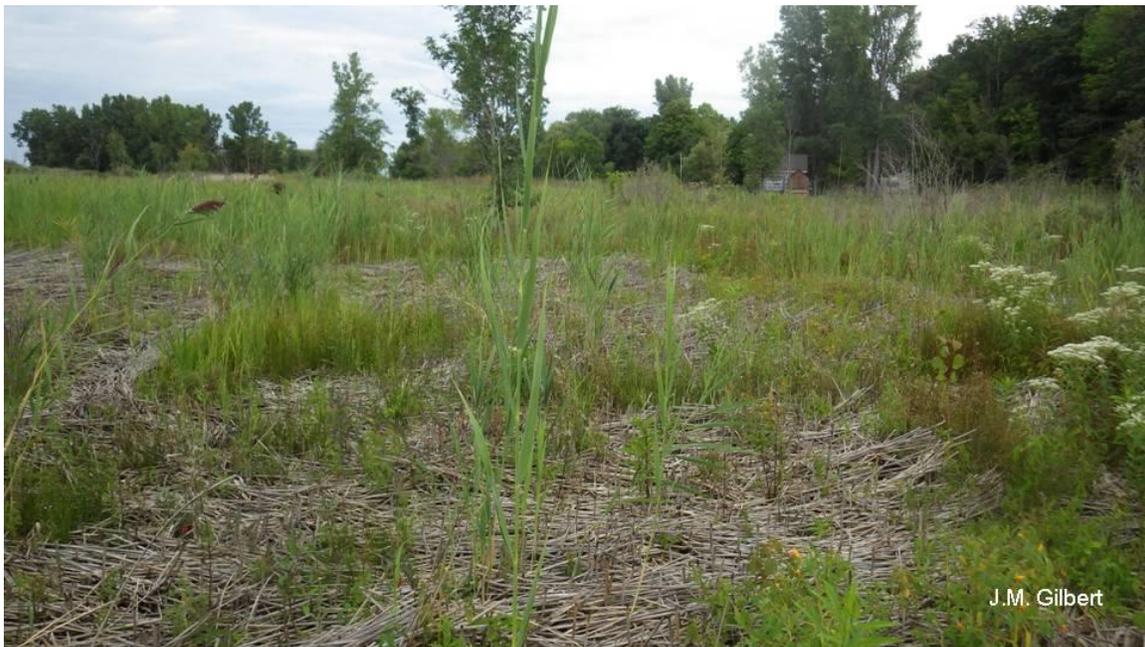
Figure 22. Native plants re-colonizing an area where dense Phragmites had been treated with herbicide and rolled, Wood Drive Coastal Wetland, August 2016.

As a result of the control efforts that had been undertaken in 2014 and 2015 within the narrow, dry section of the meadow marsh, Phragmites had been reduced from a high density monoculture to ~17% coverage. Plant stature was also lower at < 2.5 m compared to the untreated areas where heights exceeded 3 m. Within the majority of the plots, Phragmites densities ranged between <1% and 35% with the highest coverage at 60%. Despite the control efforts, Phragmites remained, by far the most abundant plant. *Chara sp.* (Stonewort) was the next most abundant species with a relative coverage of ~13% and a presence in 31% of the plots. However, while *Chara* has plant-like features, it is actually a colony of algae and was not included in the FQAI scores. Another invasive, *Lythrum salicaria* (Purple Loosestrife), was the second most abundant plant with a relative percent coverage of ~4.7% and a presence in 43% of the plots. Many of the *L. salicaria* appeared to be stressed and all of the plants observed had eaten leaves (Figure 23).

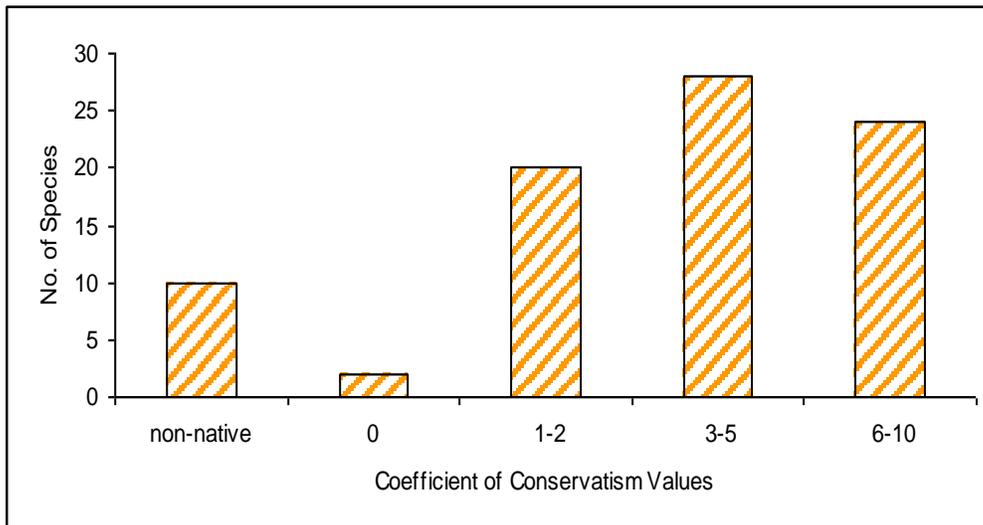
Figure 24. Number of vegetation species within each coefficient of conservatism category for the Wood Drive Coastal Wetland, 2016.

The twenty-four species with coefficient of conservatism (C of C) values between 6 and 10 had a combined relative coverage of ~11% (Figure 24). Species in these categories require specific site conditions making them more sensitive to habitat changes compared to the species which are generalists. There were 50 generalist species (C of C values between 0 and 5) with a combined relative coverage of ~18%.

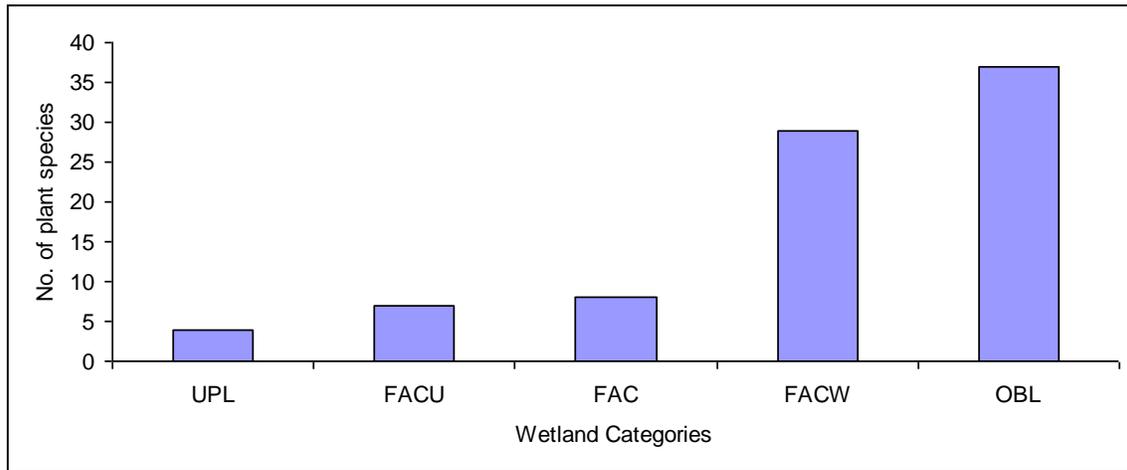
Figure 25. Number of species within each wetland category, Wood Drive Coastal Wetland, 2016.

The majority of the species observed were either obligate wetland (37 spp.) or facultative wetland (29 spp.; Figure 25). The high number of obligate wetland species was indicative of the wetter conditions which occurred in 2015 and 2016 as a result of increased lake levels (Figure 26). During the growing season (May through August) Lake Huron was on average 0.29 m higher in 2015 compared to 2014 and 0.15 m higher in 2016 compared to 2015. This increase resulted in flooded conditions throughout much of the meadow marsh and in many areas the sustained flooding was sufficient to kill trees (Figure 27). There was also a noticeable decline in facultative species including asters, goldenrods and grasses which had been observed throughout the meadow marsh in 2014 when conditions were much drier. Native plant recovery was also low in flooded areas where dense Phragmites had been treated in 2014, (Figure 28). This dampened response is attributed to permanently flooded conditions and the thick layer of dead Phragmites. For various viable seeds in a seed bank to germinate a draw down period is required and until the thick layer of Phragmites sufficiently decays it will remain a barrier to plant colonization.

UPL=upland, FAC=Facultative, FACU=facultative upland, FACW=facultative wetland, OBL=obligate wetland

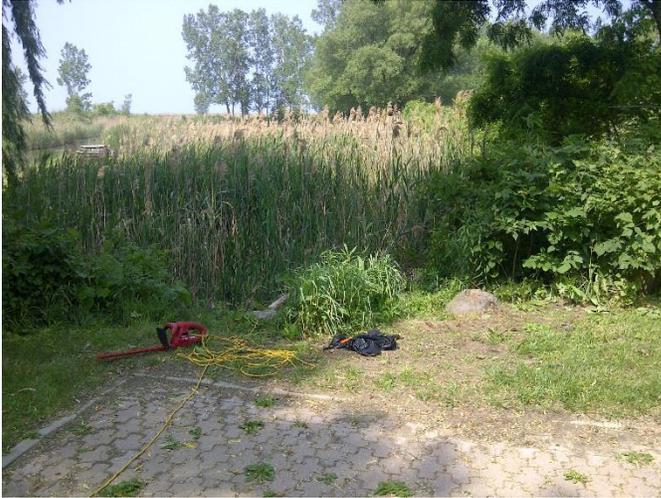
June 6, 2013 from our patio

While in my teens my parents purchased their second property on Wood Drive. Phragmites at that time had never been heard of. Due to various reasons my parents did not attend the cottage until approximately three years ago. The cottage was renovated internally however, the property needed to be landscaped and the jungle of phragmites in the channel directly in front of our patio needed to be removed. At that time, you could not see the water in the "moat" as I

During the first summer three years ago, I was working solo at removing the phragmites and burning them. Finding they grew a foot within a week of cutting. At that time I was using garden sheers, a whipper snipper and my hedge trimmer to try and manage the phrags, with not much luck.
